# TSSU Bulletin

August '2000

Volume 2000-2.

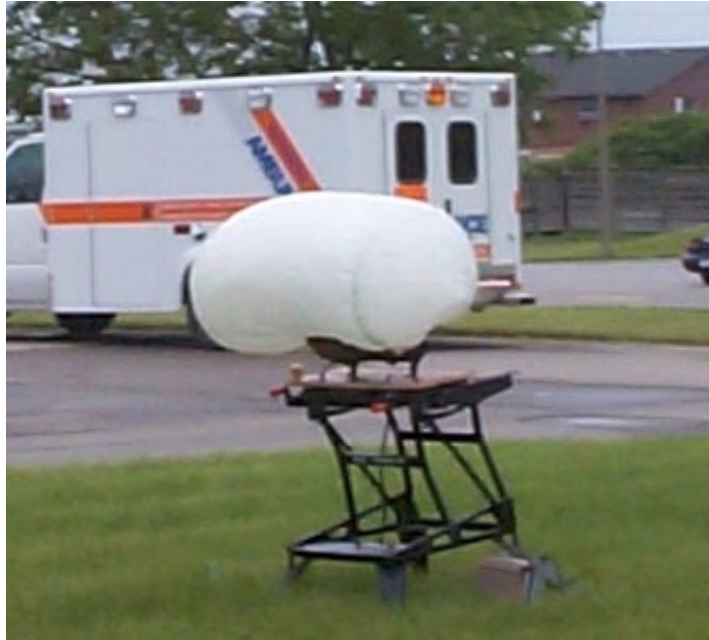
## 6.) AIR BAGS & SAFETY.

An air bag demonstration that was provided by an air bag repair expert at the Safe Driving competition in Milton demonstrated some of the hazards involved with air bags. Two different bags were activated in the demonstration and the rate of deployment was impressive.

During discussion it was pointed out that drivers should no longer utilize the 10-2 holding positions on the steering wheel due to airbags but should adopt a lower grip on the wheel.

If a bag deploys it could throw your hands & arms into your face or head, causing serious injury.

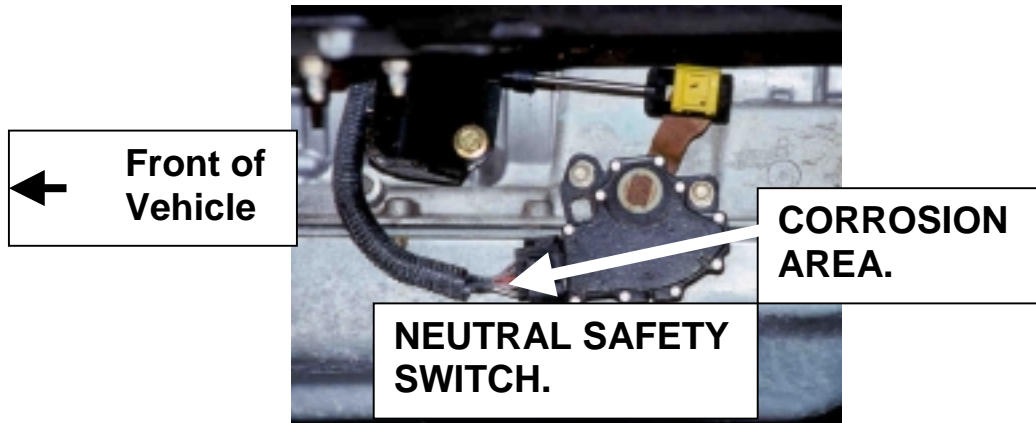
### Transmission Neutral Safety Switch.

Problem: Starting in park. No start or intermittent start.

Before replacing the starter, check the neutral safety switch on the side of the transmission for corrosion. The wiring harness is open to corrosion and this could be your problem! **Thanks Larry!**

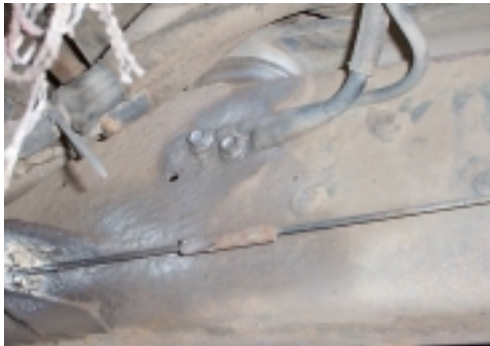
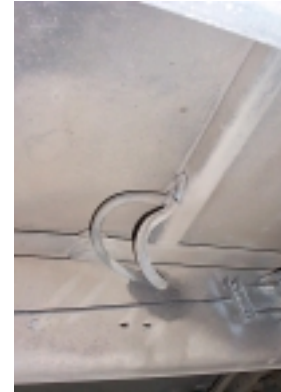
### Battery Cables & Posts.

**MUST BE CLEANED!!!**

“A” inspection item #11. Please remind your service repair outlet that all ground cables are to be **checked and cleaned** while performing this section of the maintenance schedule. These under-the-vehicle ground cables, have been found to cause a great number of electrical & charging system problems and failures.

We recommend that each connection should be DISCONNECTED, and CLEANED with a grinder or wire brush to ensure a good metal to metal fit when reconnected. (New hardware is recommended).

Cables that are found to be brittle or discolored are to be replaced.
